November 14, 2014

Re: Masonry Wall Construction Assessment at Belmont Mill

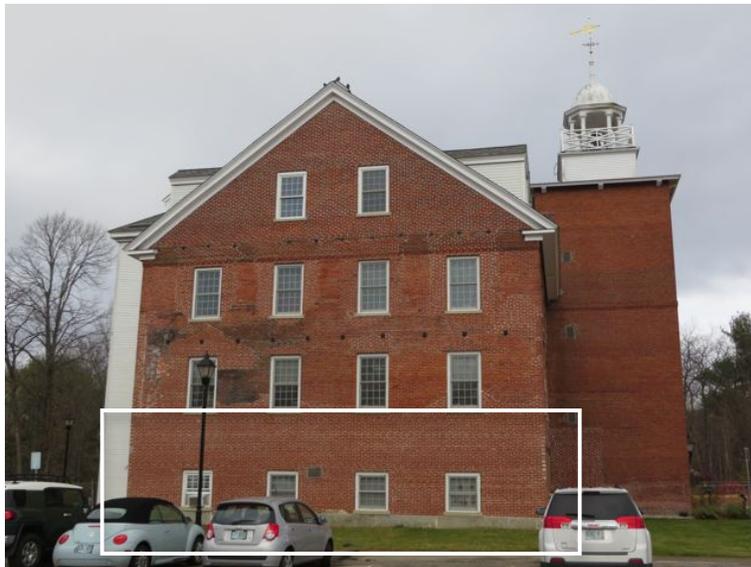
The area of masonry assembly on the south elevation of the building below the second floor is the area subjected to the intense heat and conversely the rapid cooling as water was applied to extinguish the fire in 1992. When masonry assembly is subjected to the strong swings between heating and cooling, the masonry units become fractured and the mortar breaks down. Repairs after the fire appear to be limited to the first and second wythe of the assembly, but observations of the interior wall surface reveal the damage went much deeper. At the time of the repairs, this damage would not have revealed itself or it was not obvious. The interior masonry wall assembly is not solid. The mortar is a soft, sandy mass providing reduced compressive strengths for the design of the mass-load-bearing assembly. Moisture readings at three access points recorded high levels of moisture in the masonry assembly. These levels are considered abnormal as compared to undamaged wall sections. Mortar “pick tests” revealed excessive surface deterioration of the original mortar.

Area of Fire Damaged Masonry

Overall the masonry wall assembly (with one exception) of the Belmont Mill is in good condition for the age of the building and is a viable building element in the renovation of the mill. The one exception is the masonry wall assembly subjected to the fire in 1992. This section of the assembly will need additional repair measures above the standard restoration repairs, but costs associated with the measures should not create a disproportional burden on the construction budgets. The variations with brick units and pointing mortars on the exterior façade is reversible and once completed, will create a uniform appearance as opposed to the current patchwork look.

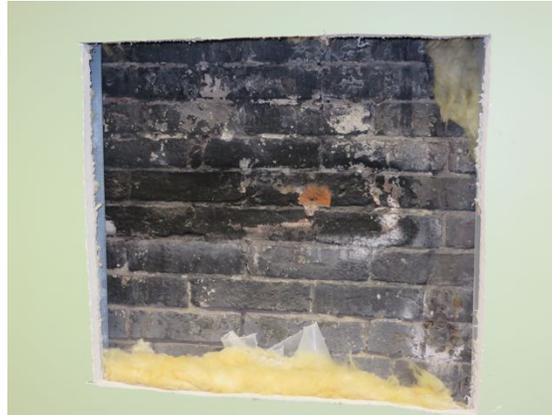
Interior face of Fire Damaged Wall

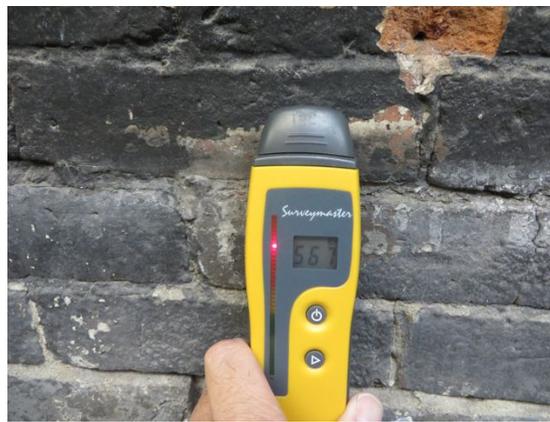
Typical Moisture Readings on South Wall below Second Floor.
