GOVERNOR'S COMMISSION
ON DISABILITY

ARCHITECTURAL BARRIER-FREE
DESIGN COMMITTEE

August 19, 2004

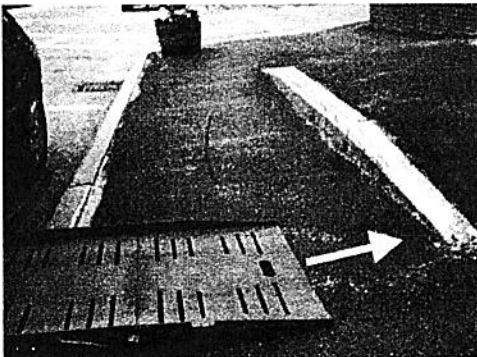
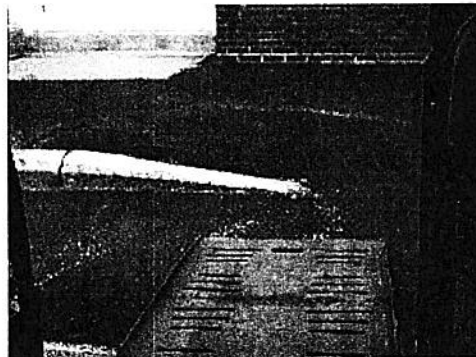
There should be at least one van-accessible parking space (a 96 inch wide space with an adjacent 96 inch wide access aisle). The existing on-street parallel *accessible* parking space is not compliant per ADAAG 4.6. An on-street parallel parking configuration cannot provide the required access aisle (ADAAG 4.6.3). The sidewalk has within it an additional curbing and a second level of sidewalk which, for a van with a lift or ramp that deploys on the passenger side of the vehicle, results in insufficient maneuvering space (a minimum of 96 inches in width). For other vehicles, either the driver would be forced to maneuver a wheelchair within the path of traffic or the passenger would have to maneuver the wheelchair next to the vehicle, several inches above the street level, on the sidewalk. Both of these are difficult and dangerous maneuvers.

Gary did state that handrails will be installed along this second level of the sidewalk to prevent falls from one level to the other, however, it remains that the location of this sidewalk interferes with exiting a vehicle.

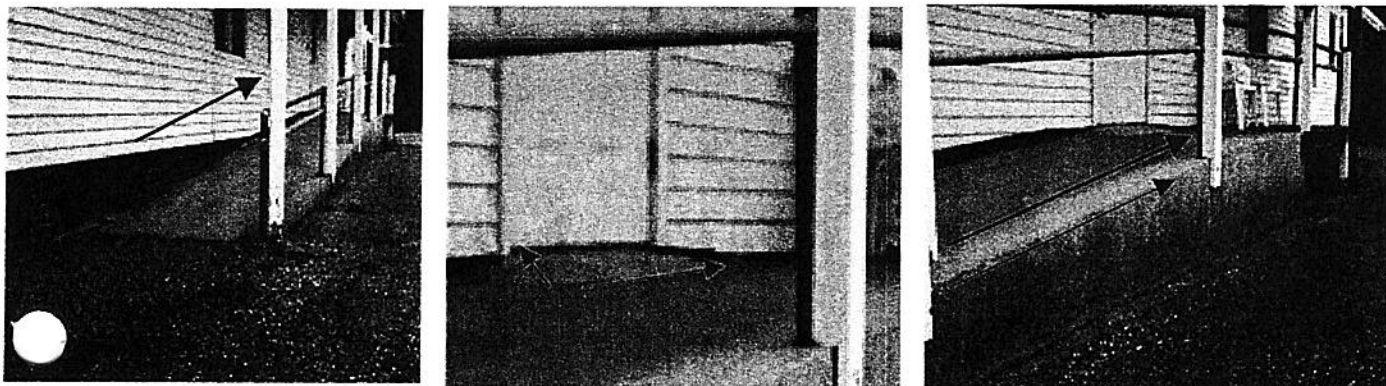
The ramp does not meet the requirements of section 4.8 of ADAAG. The slope exceeds 1:12 (4.8.2) – the ramp is 32 inches in height and 26 feet 7 inches in length, for a grade of approximately 1:10; the landing at the top does not comply with 4.8.4, there is only one handrail where they should be on both sides of the ramp (4.8.5 (1)), and there is no edge protection along the street side of the ramp (4.8.7).
