## Belmont bandstand stands out in original colors

By TIM CAMERATO | Jul 02, 2014

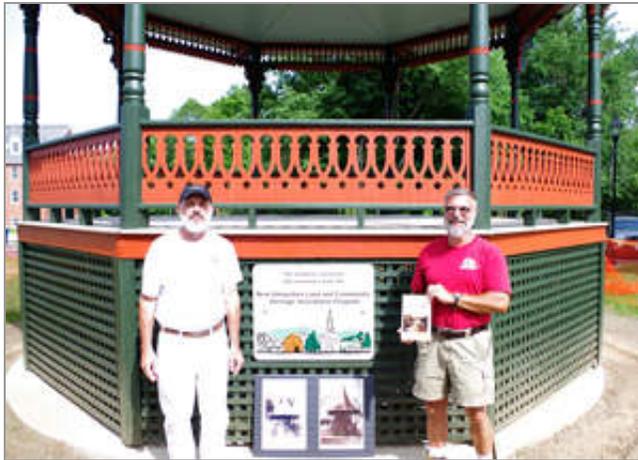
RESTORATION EXPERT JR Graton, right, and restoration painter John Thompson, left, are both responsible for the work recently done on the Belmont bandstand.

Restoration painters recently finished work to bring the exterior of the structure back to its original 1908 colors.

He said workers started by placing staging all around the bandstand and covering it with plastic to keep the paint that chipped off contained. They then removed the majority of the old paint using Peel Away.

“You put the Peel Away on, you put a paper over it, and let it set for 24 hours or so, and you peel it off,”

Thompson said. “It takes most of the paint off. The rest of it is taken off with hand labor.”

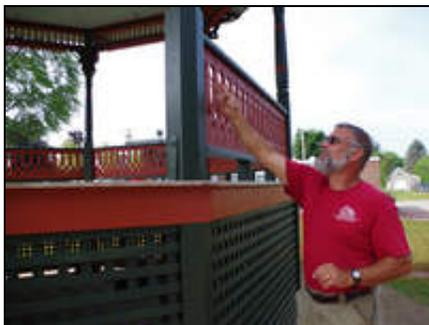
**BELMONT** — People traveling on Main Street might have noticed that the historic bandstand near the library is now a lot more vibrant.

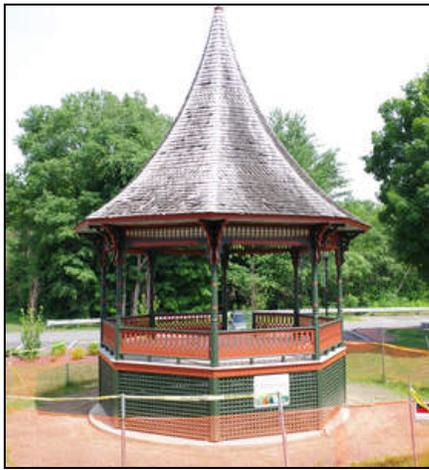
An exterior paint study of the bandstand was published in May by Building Conservation Associates Inc. They found that “the original paint treatment was predominantly a very dark blackish green with selected elements accented in red.”

Restoration painter John Thompson of JLT Painting in Alexandria did the painting of the bandstand.
