## Historic restoration specialist hopes to return bandstand to its original splendor

Painting and a new roof are part of Phase 2 for Belmont’s bandstand restoration project, which was made possible through an LCHIP challenge grant and matching funds from the Belmont Heritage Commission. The goal is to restore as much of the original structure as possible and to have any necessary repairs recreated to look like the original.

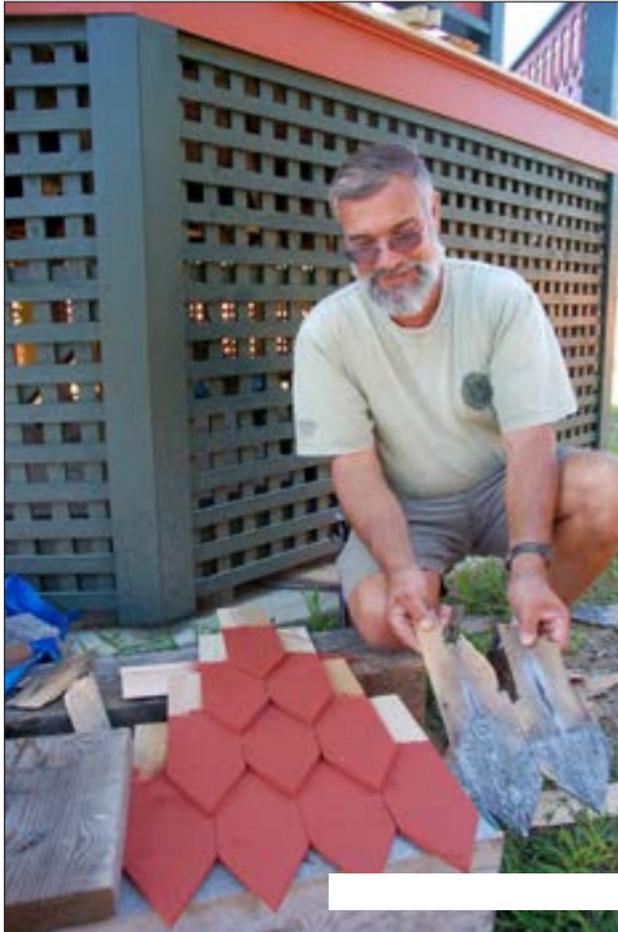
**Historic restoration specialist JR Graton of Northfield compares the old wood shingles he has been removing from the Belmont bandstand with the new shingles he has handmade so that the structure will once again look as it did when it was built in 1908.**

“The dipping is probably the hardest part of all of this because it takes so long. I have 86 clothespins, so I can dip 86 shingles at a time and hang them up to dry,” he said.

For the past few weeks, he has been busy pulling the old wood shingles off so he can replace them with the new ones he has been creating back at his workshop.

In all, Graton said he has more than 1,000 shingles of varying size to cut for the eight-sided roof. Besides the standard rectangular pieces, there are also a few rows of pointed, decorative shingles that he must hand cut as well. Once cut, each piece in hand dipped into the red paint that will bring back the original appearance and
