# REQUEST FOR PROPOSALS

## BELMONT, NH — Historic Bandstand Preservation Project

The Town of Belmont, New Hampshire, assisted by its Selectmen-appointed Heritage Commission, seeks interest, bids and qualifications for the **Historic Bandstand Preservation Project**.

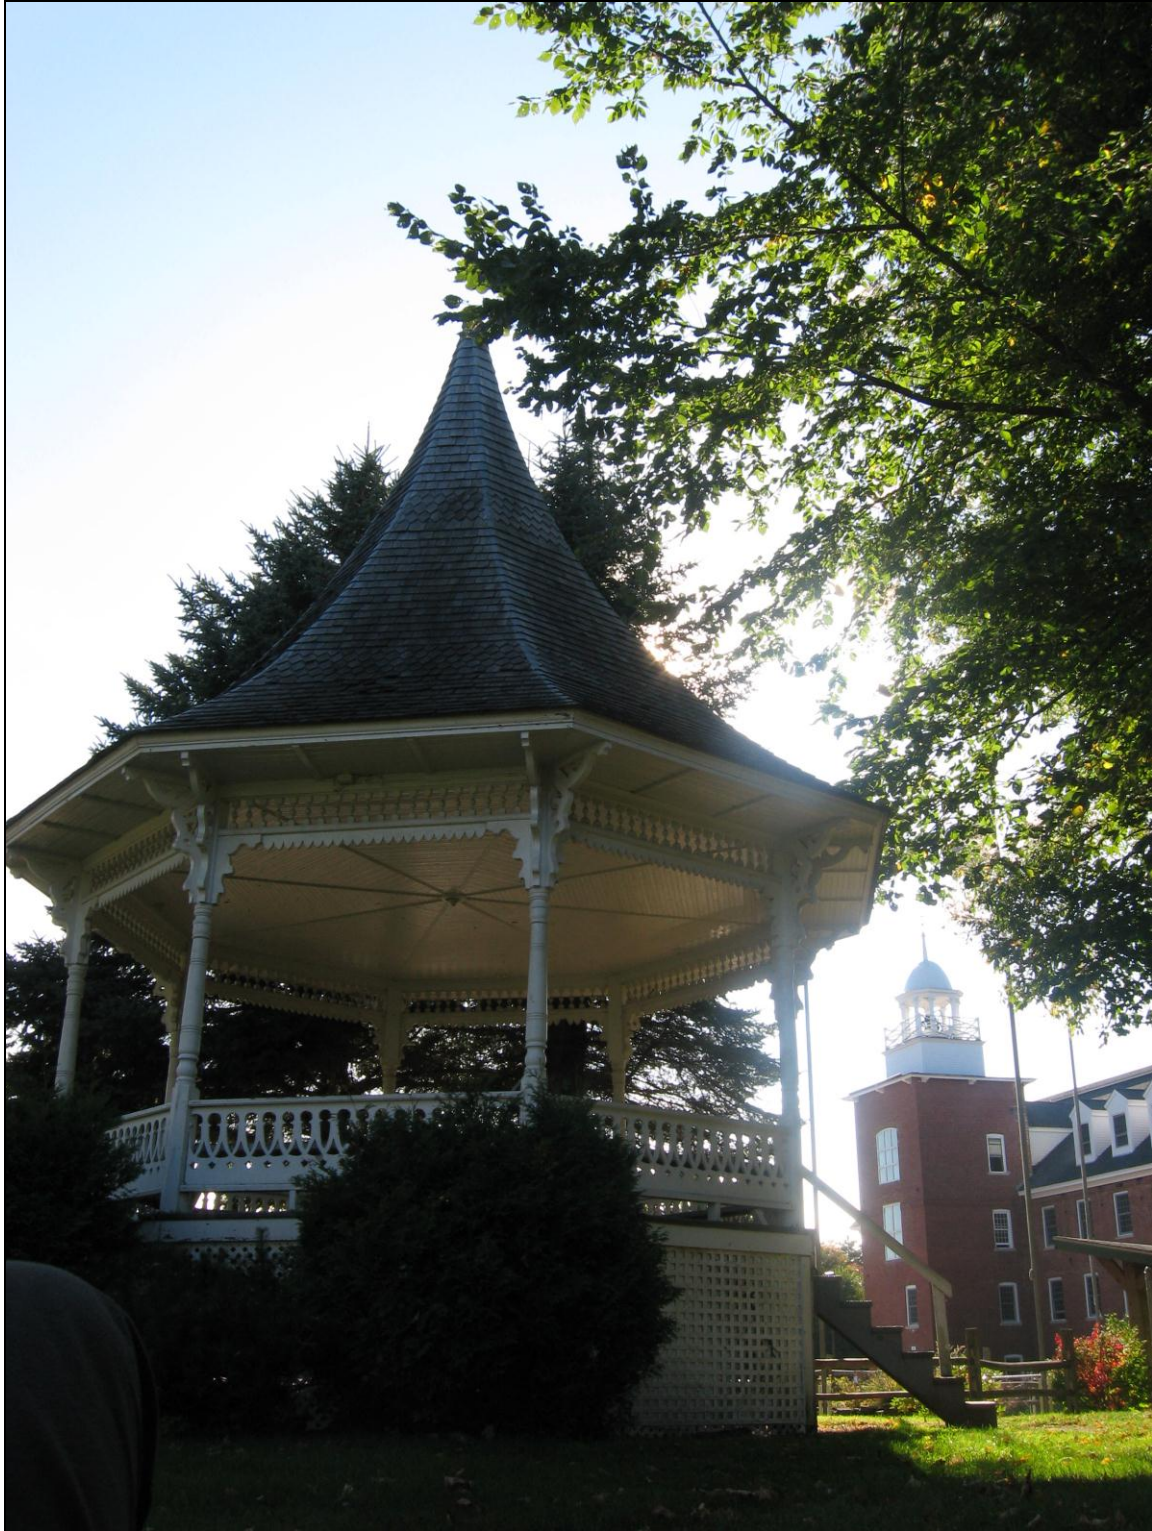
Historic Belmont Village Bandstand, 2011

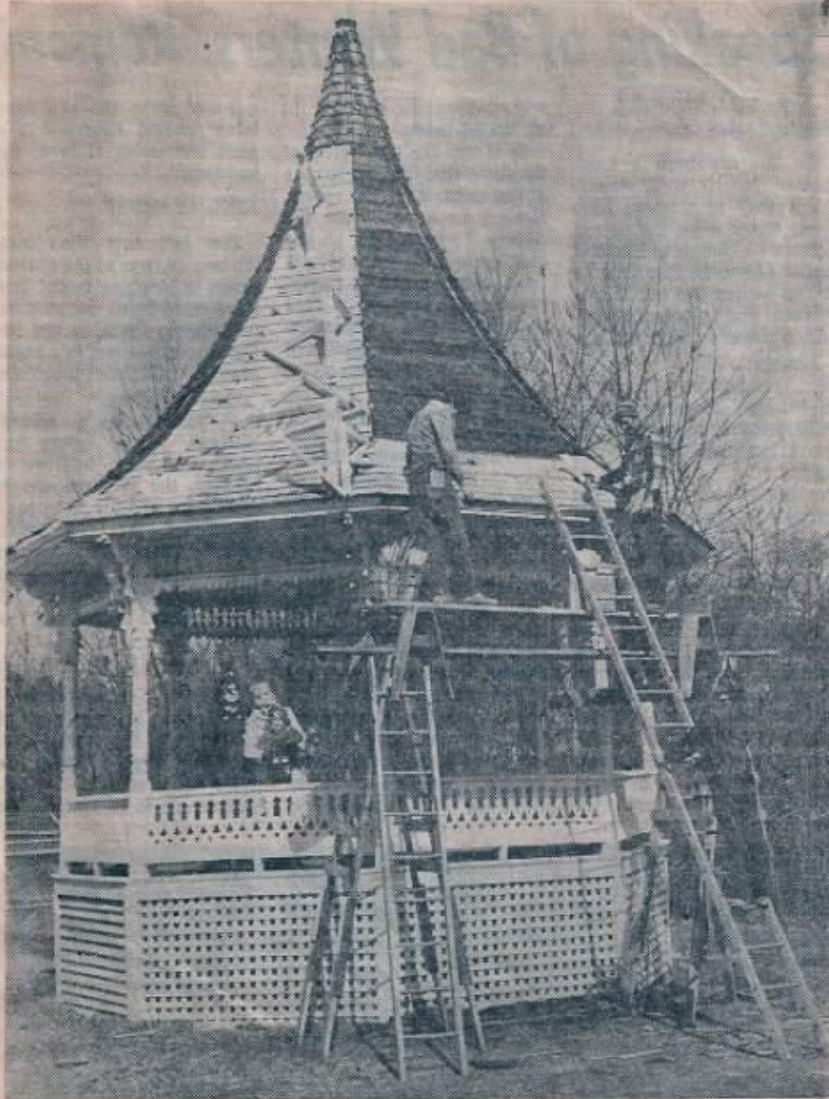
**BELMONT BANDSTAND** restoration is well under way as a belated Bicentennial project. The structure, dating back almost a century, has many unusual features, including gingerbread railing and trim, and a sloping floor, to facilitate runoff of melted snow. State Rep. Wilson Mansfield, on ladder, member of the restoration committee, checks progress

Historic Belmont Village Bandstand, 1977 (courtesy of *The Citizen*, Laconia, NH)
