Looking through the bricks

Masonry inspector takes second look at Belmont Mill, report expected next week

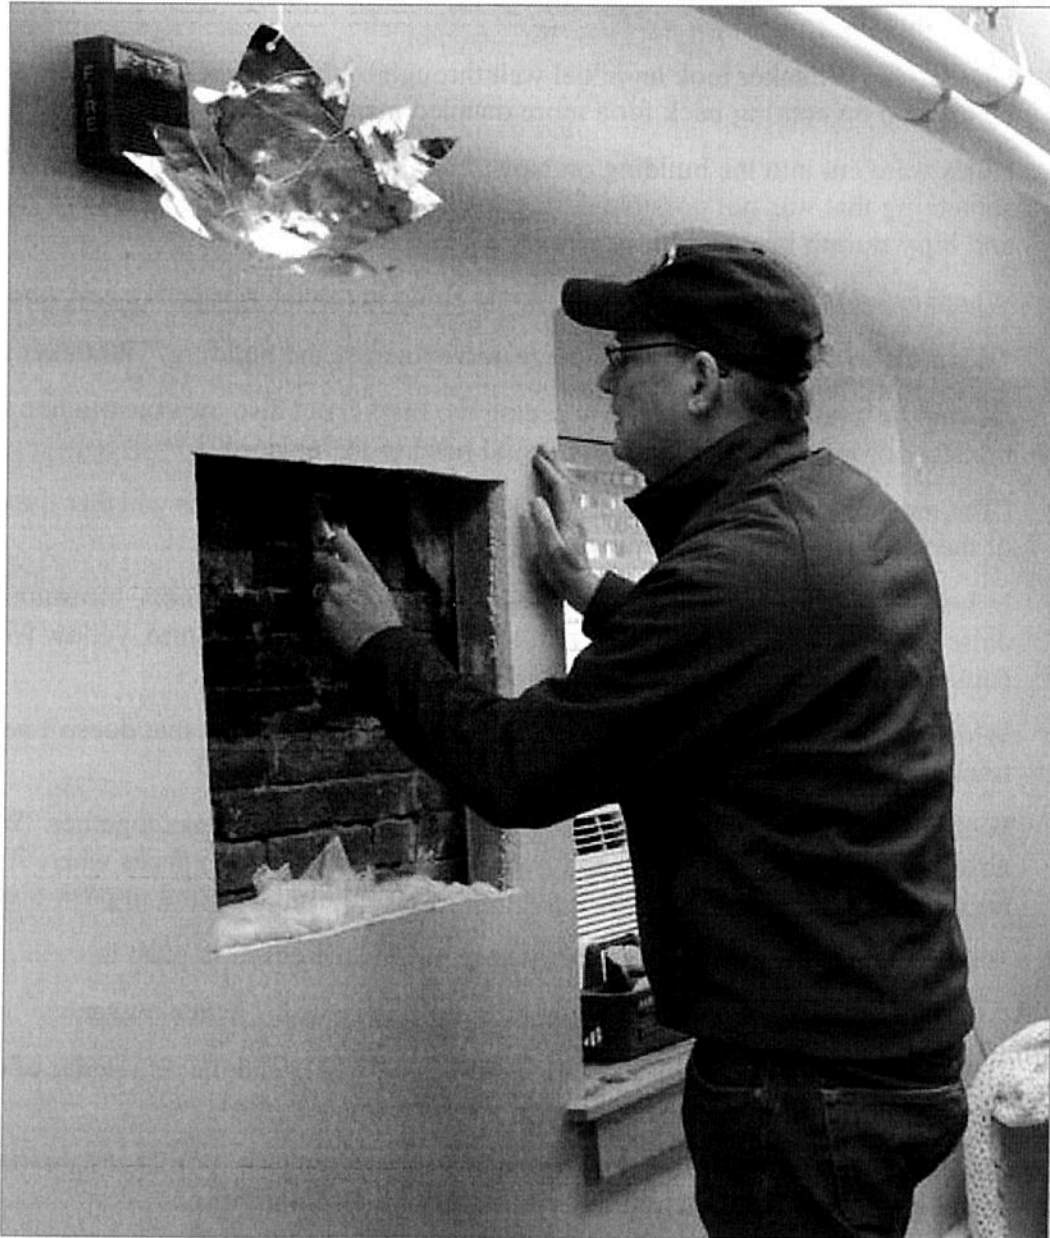
MASONRY EXPERT Scott Whitaker applies a moisture reader to the Belmont Mill's bricks inside the Belmont Early Learning Center on Wednesday.

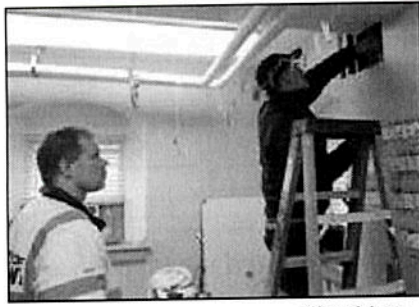
BELMONT — Looking through a hole in the building's drywall, Scott Whitaker could see sample of the Belmont Mill's brick interior. The masonry expert passed a moisture reader over portions of wall. At points, the device lit up red, in others, it was green. He then moved on to striking the bricks with a steel hammer.

Whitaker said he listens to the ringtone and action of the hammer as it hits the bricks. If it rebounds, there's solid masonry. If there's a thud, "then we've got hollows in there."

In his stack of tool boxes, Whitaker keeps his steel hammer, camera, moisture reader, and pair of chisels. He said the reader shows red when there's a lot of moisture, yellow when there's a cautionary amount, and green for reasonable amounts.

Whitaker said, if the mortar is good, it won't allow the chisel to push in.
